WYCHAVON

Management Plan

Avon Meadows
2025-2030

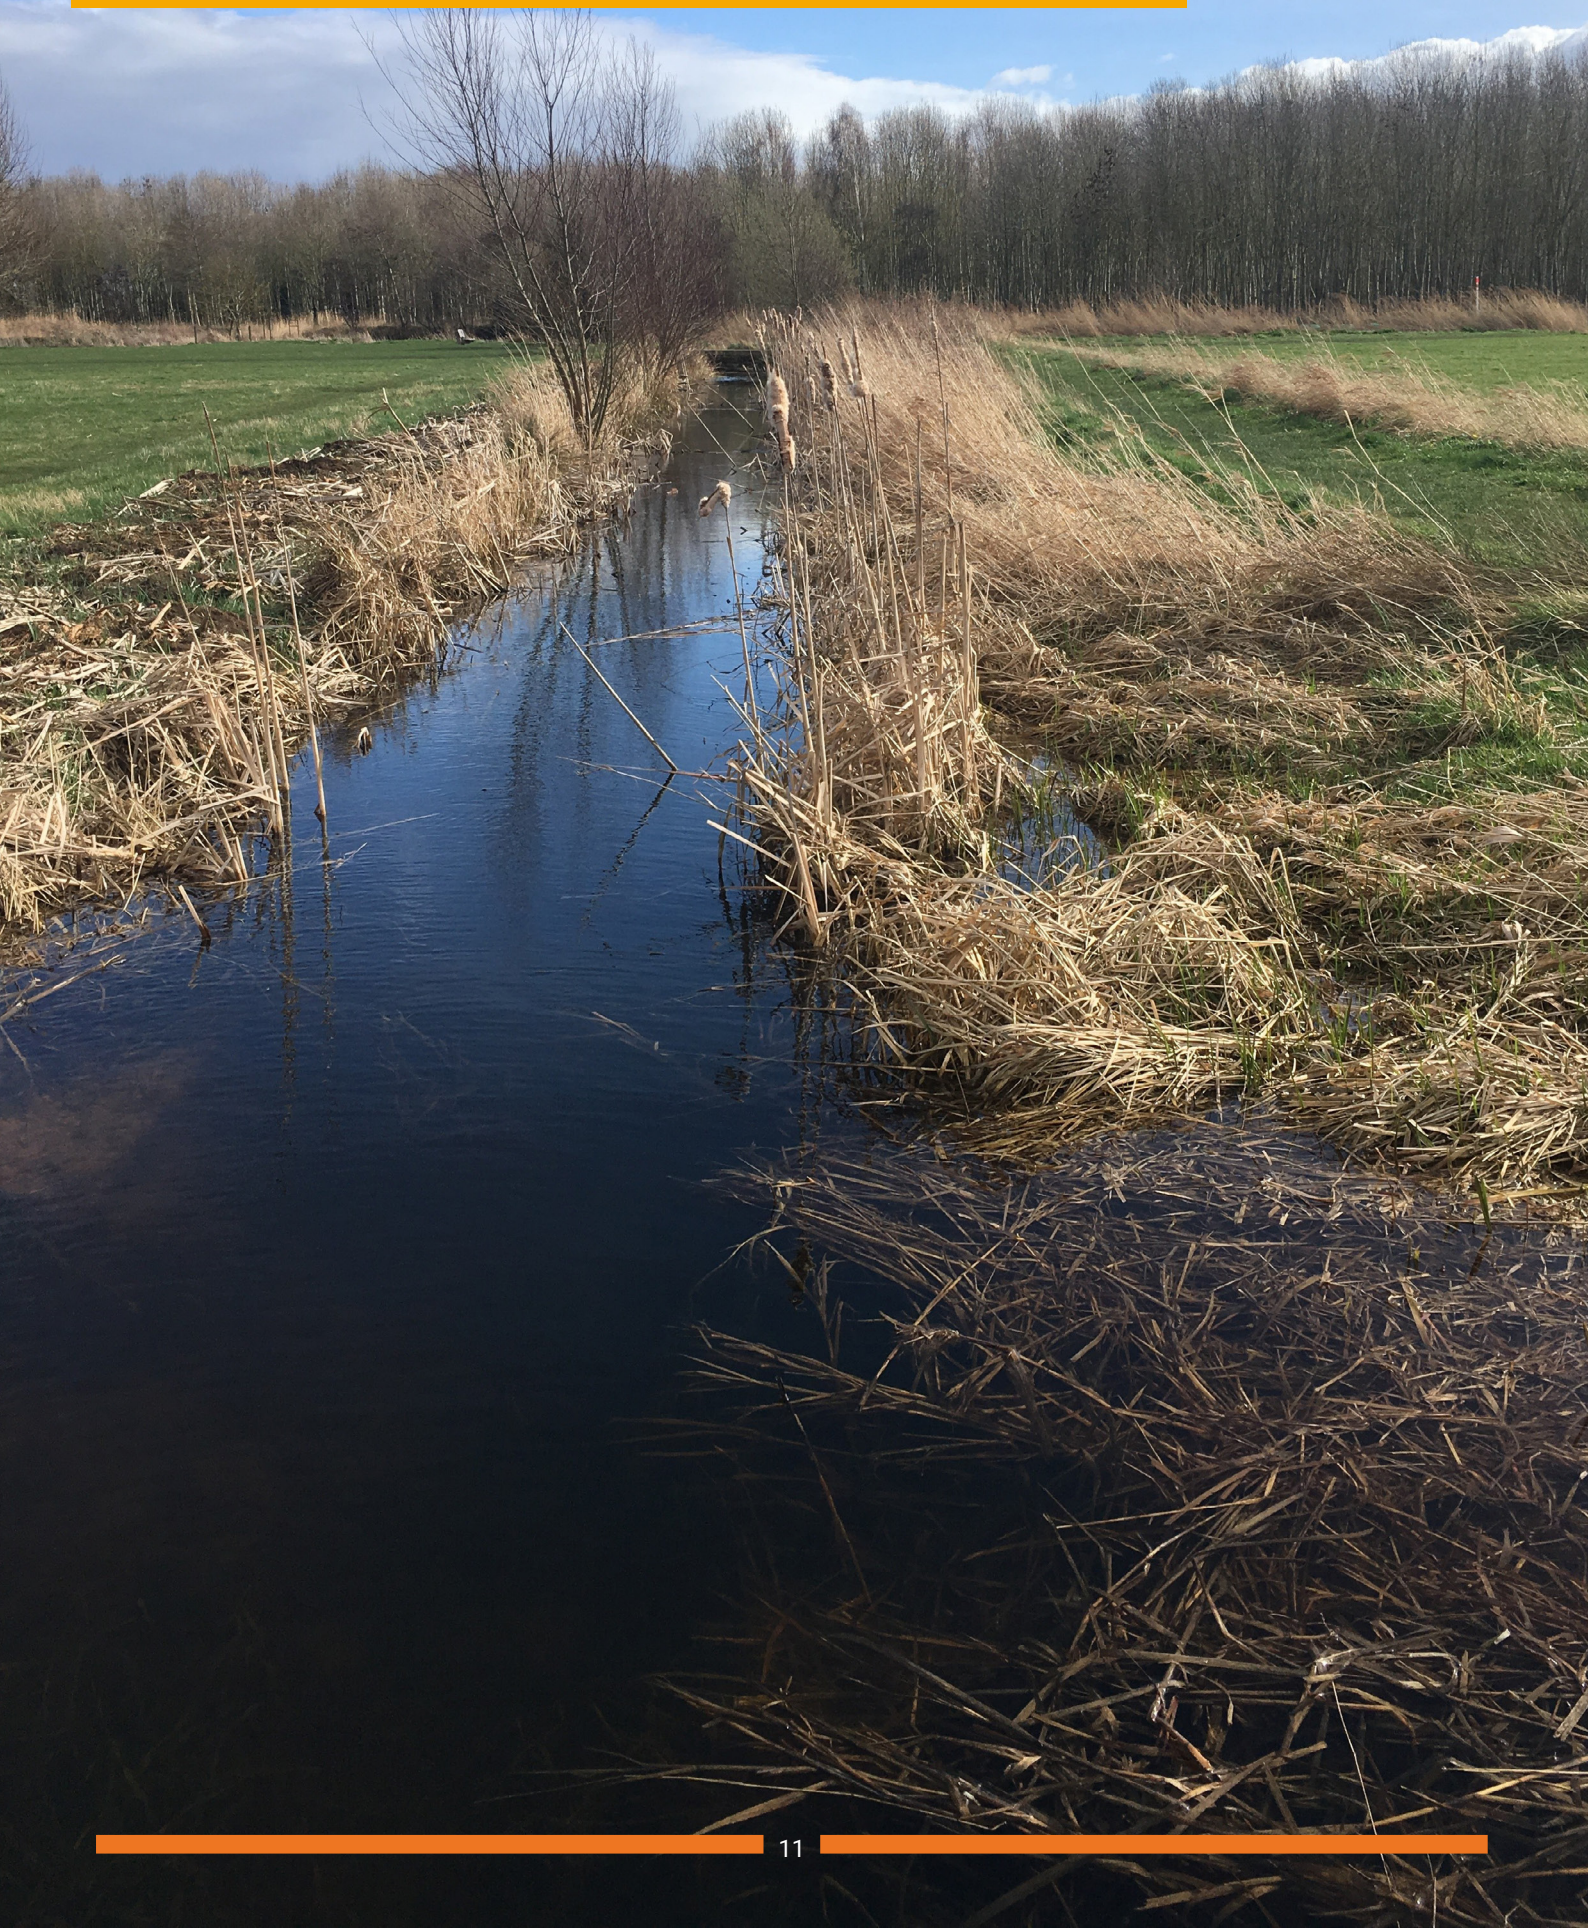
Avon Meadows Habitat Map

The Avon Meadows nature reserve consists of wet meadows, reed beds, ditches, pools, a wader scrape, areas of scrub and boundary hedgerows. Public access is freely available from several points around the meadows and a series of footpaths run around and across the site.

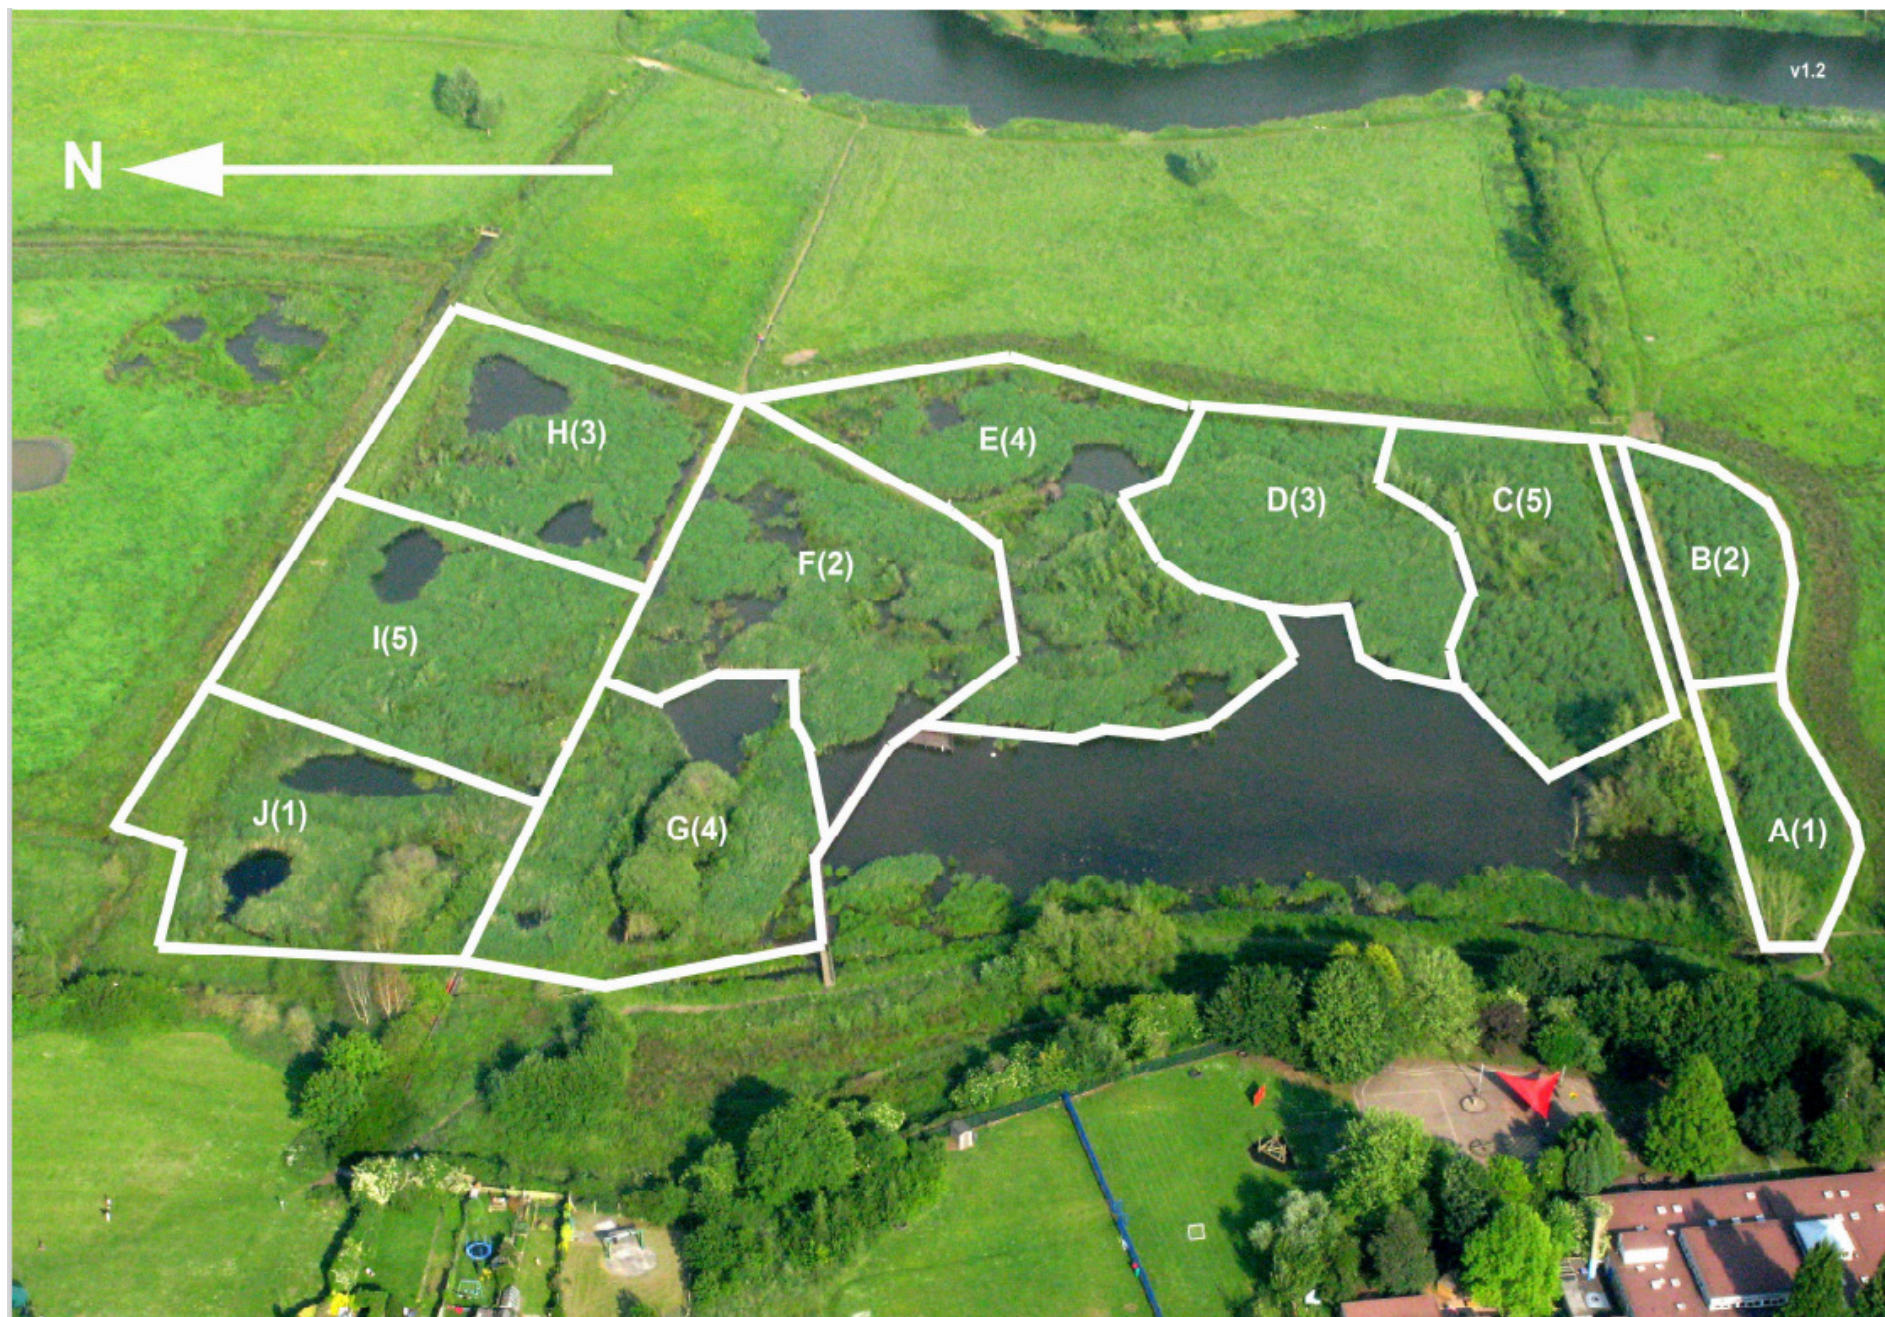
Appendix 1 – reed cutting areas

The reed planted is not suitable for commercial use like thatching, so the goal is to manage the reed beds for healthy regrowth and to create the best habitats for wildlife. To do this, the reed beds are divided into 10 areas, each cut every 5 years to encourage regrowth, with no two adjacent areas being cut in the same year. Recent fires in the reed beds have shown the need to be flexible when planning cutting – fire damaged areas will be allowed to recover before cutting resumes. A plan showing the cutting compartments is shown on page ? (Appendix)

- R1.** Continue the 5-year rotational cut and annual encroachment reed cutting programme
- R2.** Undercut reeds in agreed areas where there is encroachment
- R3.** Maintain levels of open water at 2013 aerial photograph levels as a minimum
- R4.** Control the spread of reed mace and willow scrub within the reed beds and water body margins
- R5.** Monitor for key species using the reed beds
